**BUZZARDS BAY
RAILROAD LIFT BRIDGE
OVER CAPE COD CANAL**

INSPECTION AND CONDITION REPORT

OCTOBER, 1984

MODJESKI AND MASTERS

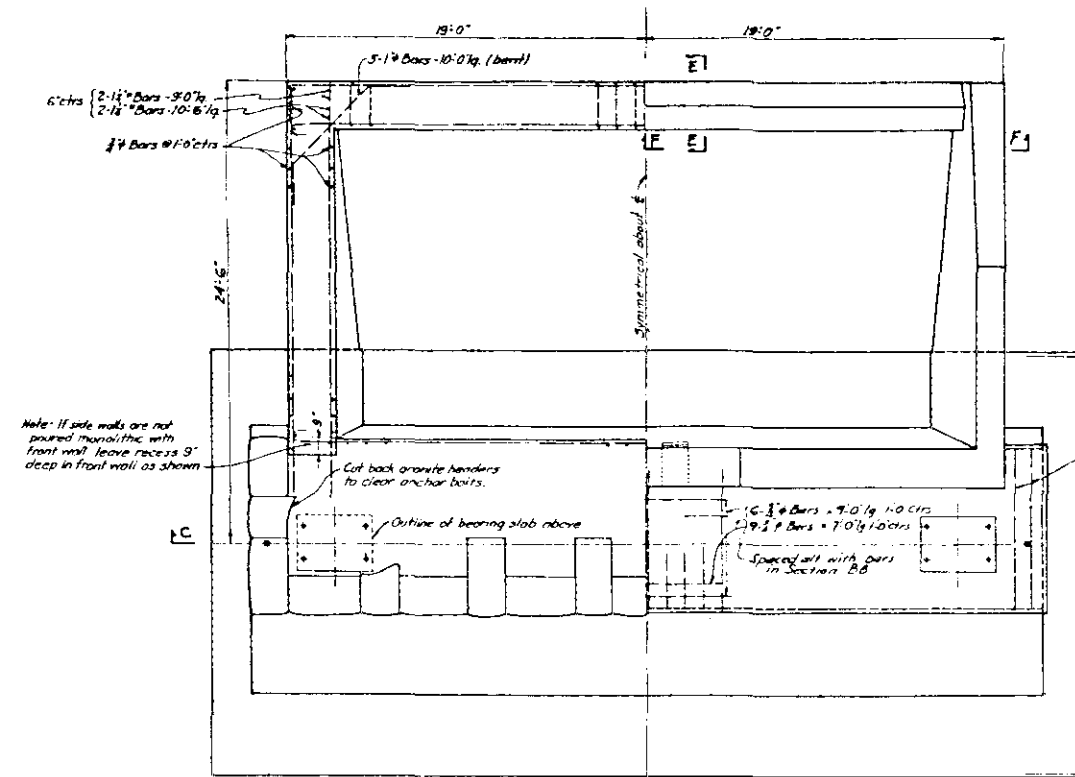
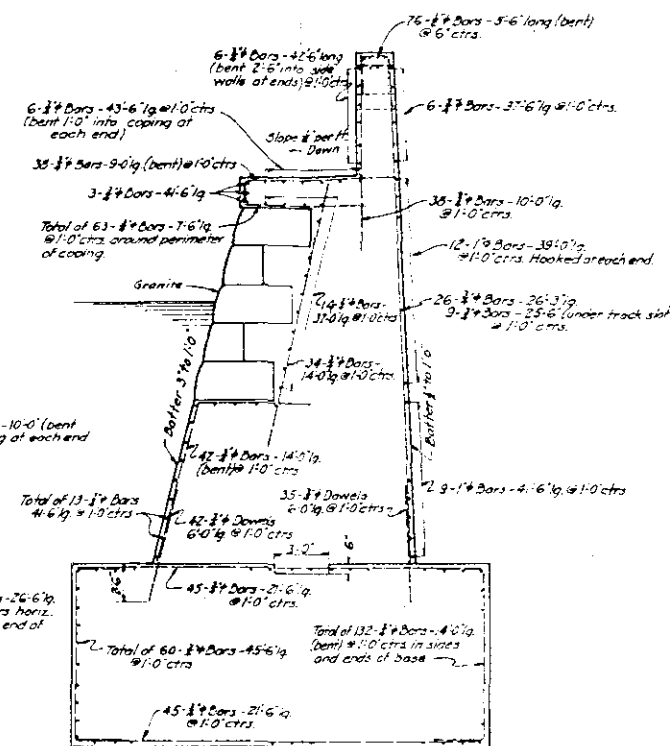
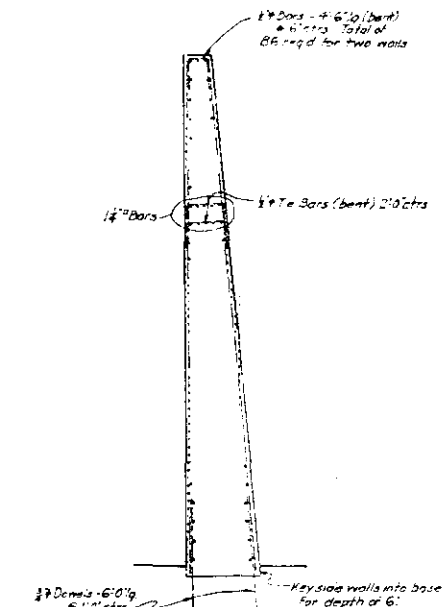
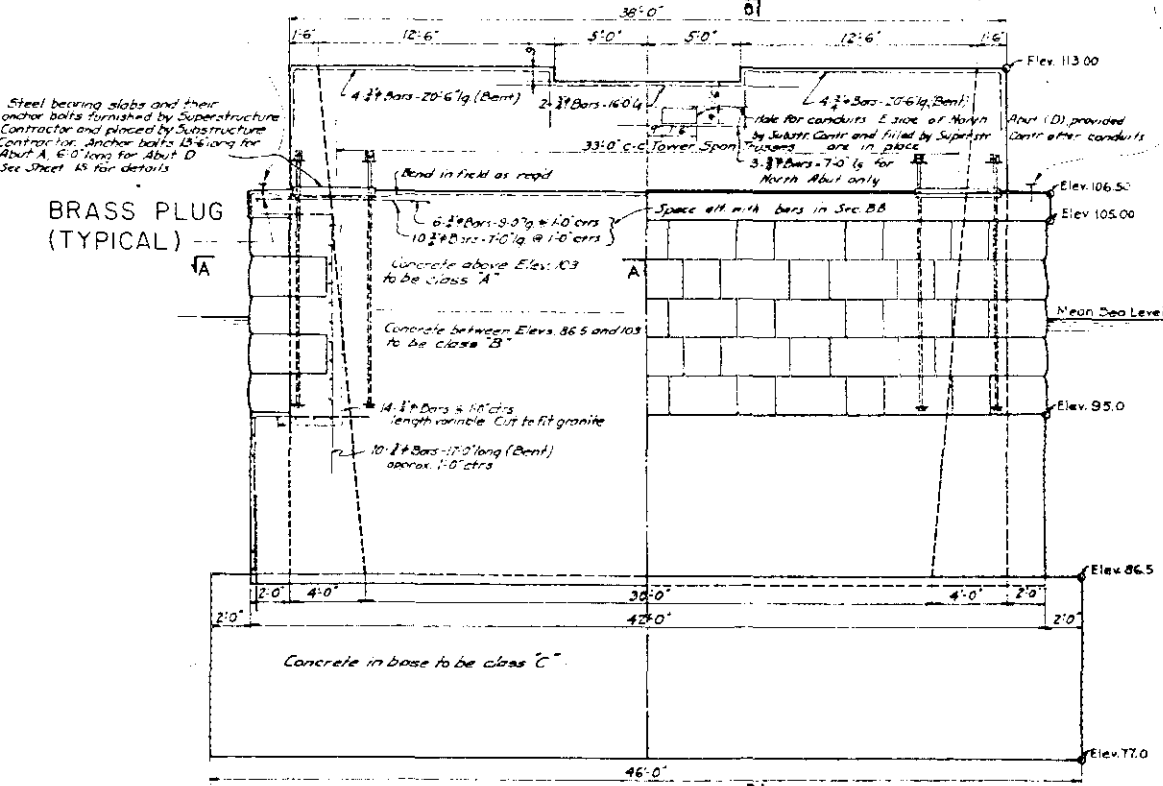
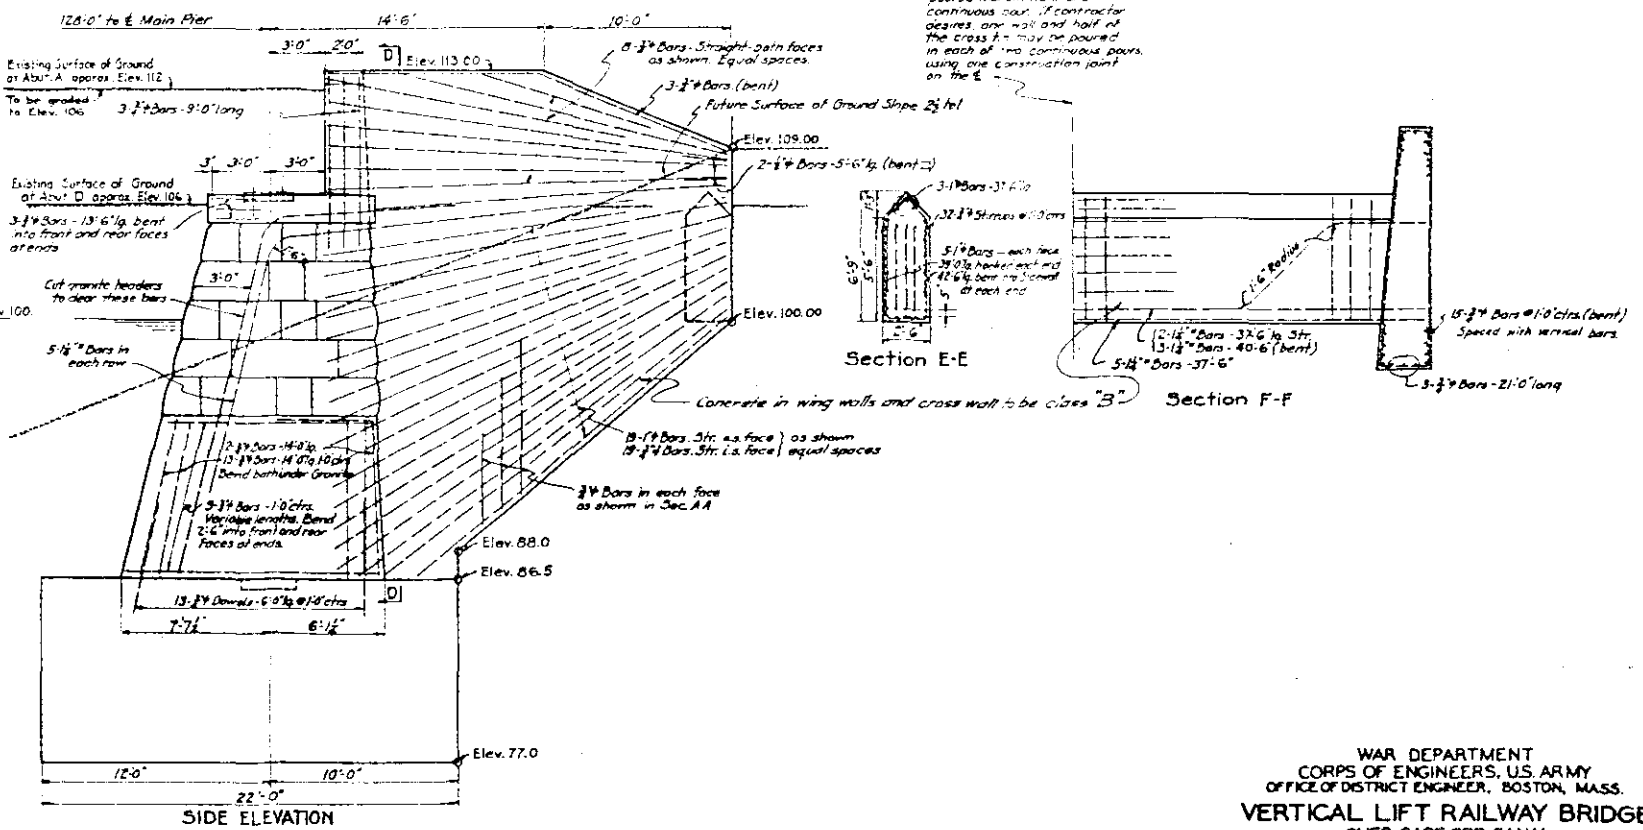
FIGURE I-2

(E) ABUTMENT A 0.017' Higher
(W) ABUTMENT D 0.026' Higher

(W) ABUTMENT A 0.004' Higher
(E) ABUTMENT D 0.023' Higher

ELEVATION CHANGES
2 NOV. '36 TO MAY '84

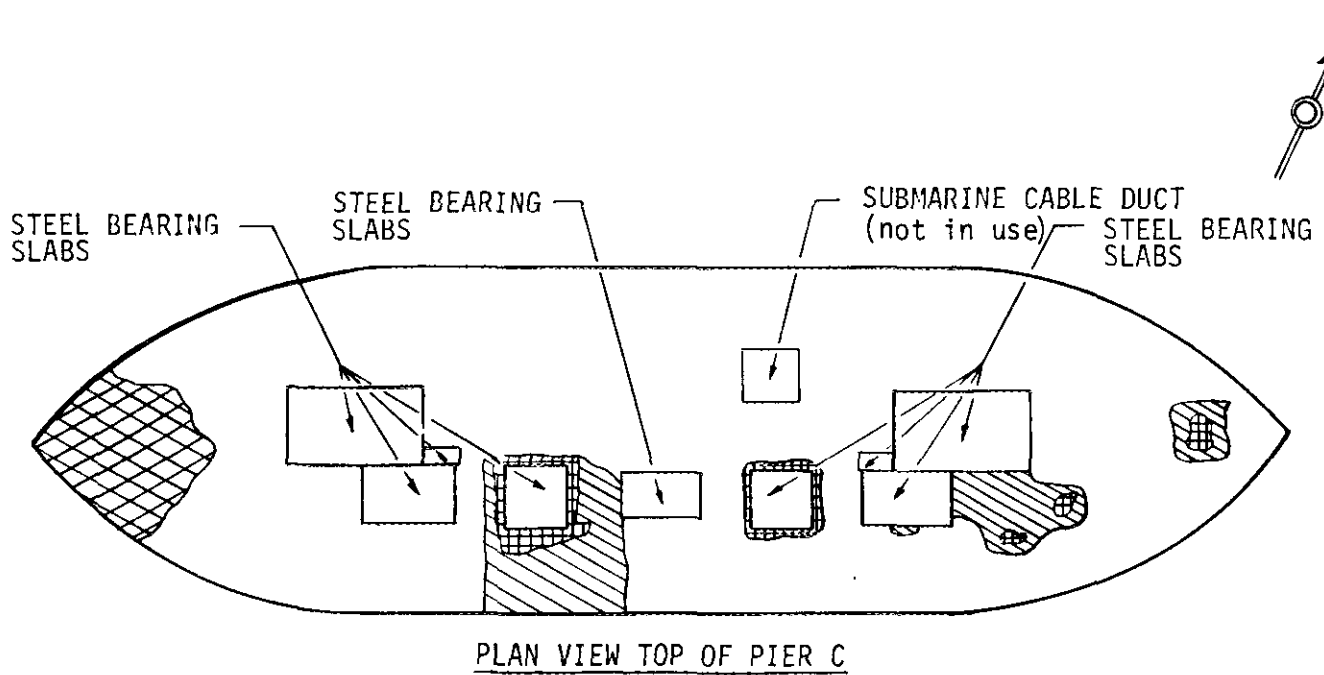
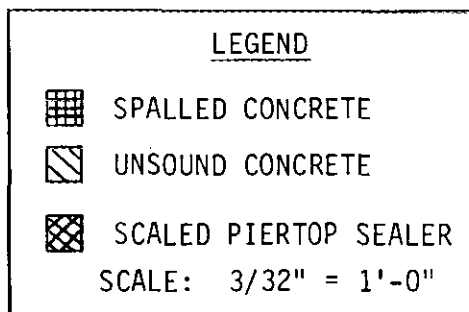
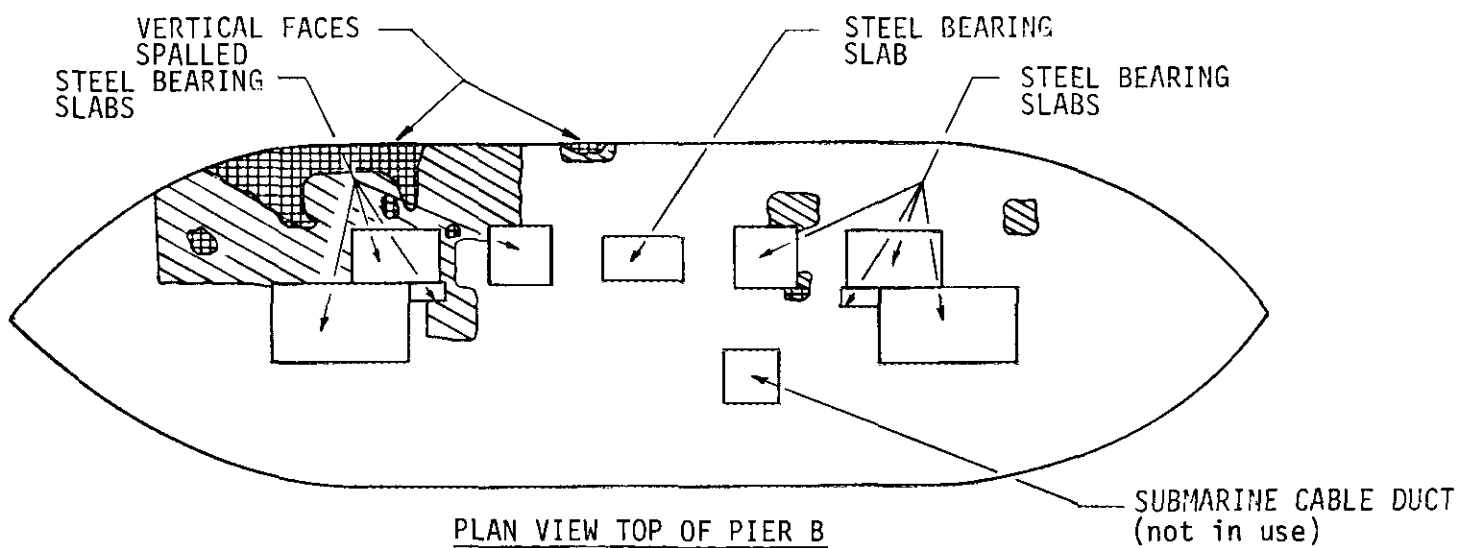
FIGURE 1-5

The concrete coping of both piers was visually examined and sounded with hammers to determine deteriorated or unsound concrete areas. The horizontal concrete surfaces of both piers are spalled (1/2 to 1 inch deep), generally around bearing plates where moisture collects. A major spalled area exists in the northwest quadrant of the Pier B coping. No reinforcing is presently exposed at the spalled areas. Pier B has approximately 160 square feet and Pier C has about 96 square feet of deteriorating and unsound concrete. Transverse hairline cracks of minor significance exist in the upper surfaces of both piers. Figure 1-5 and Photographs I-3 and II-36, 40 and 41 show the spalled and unsound concrete areas on the pier tops.

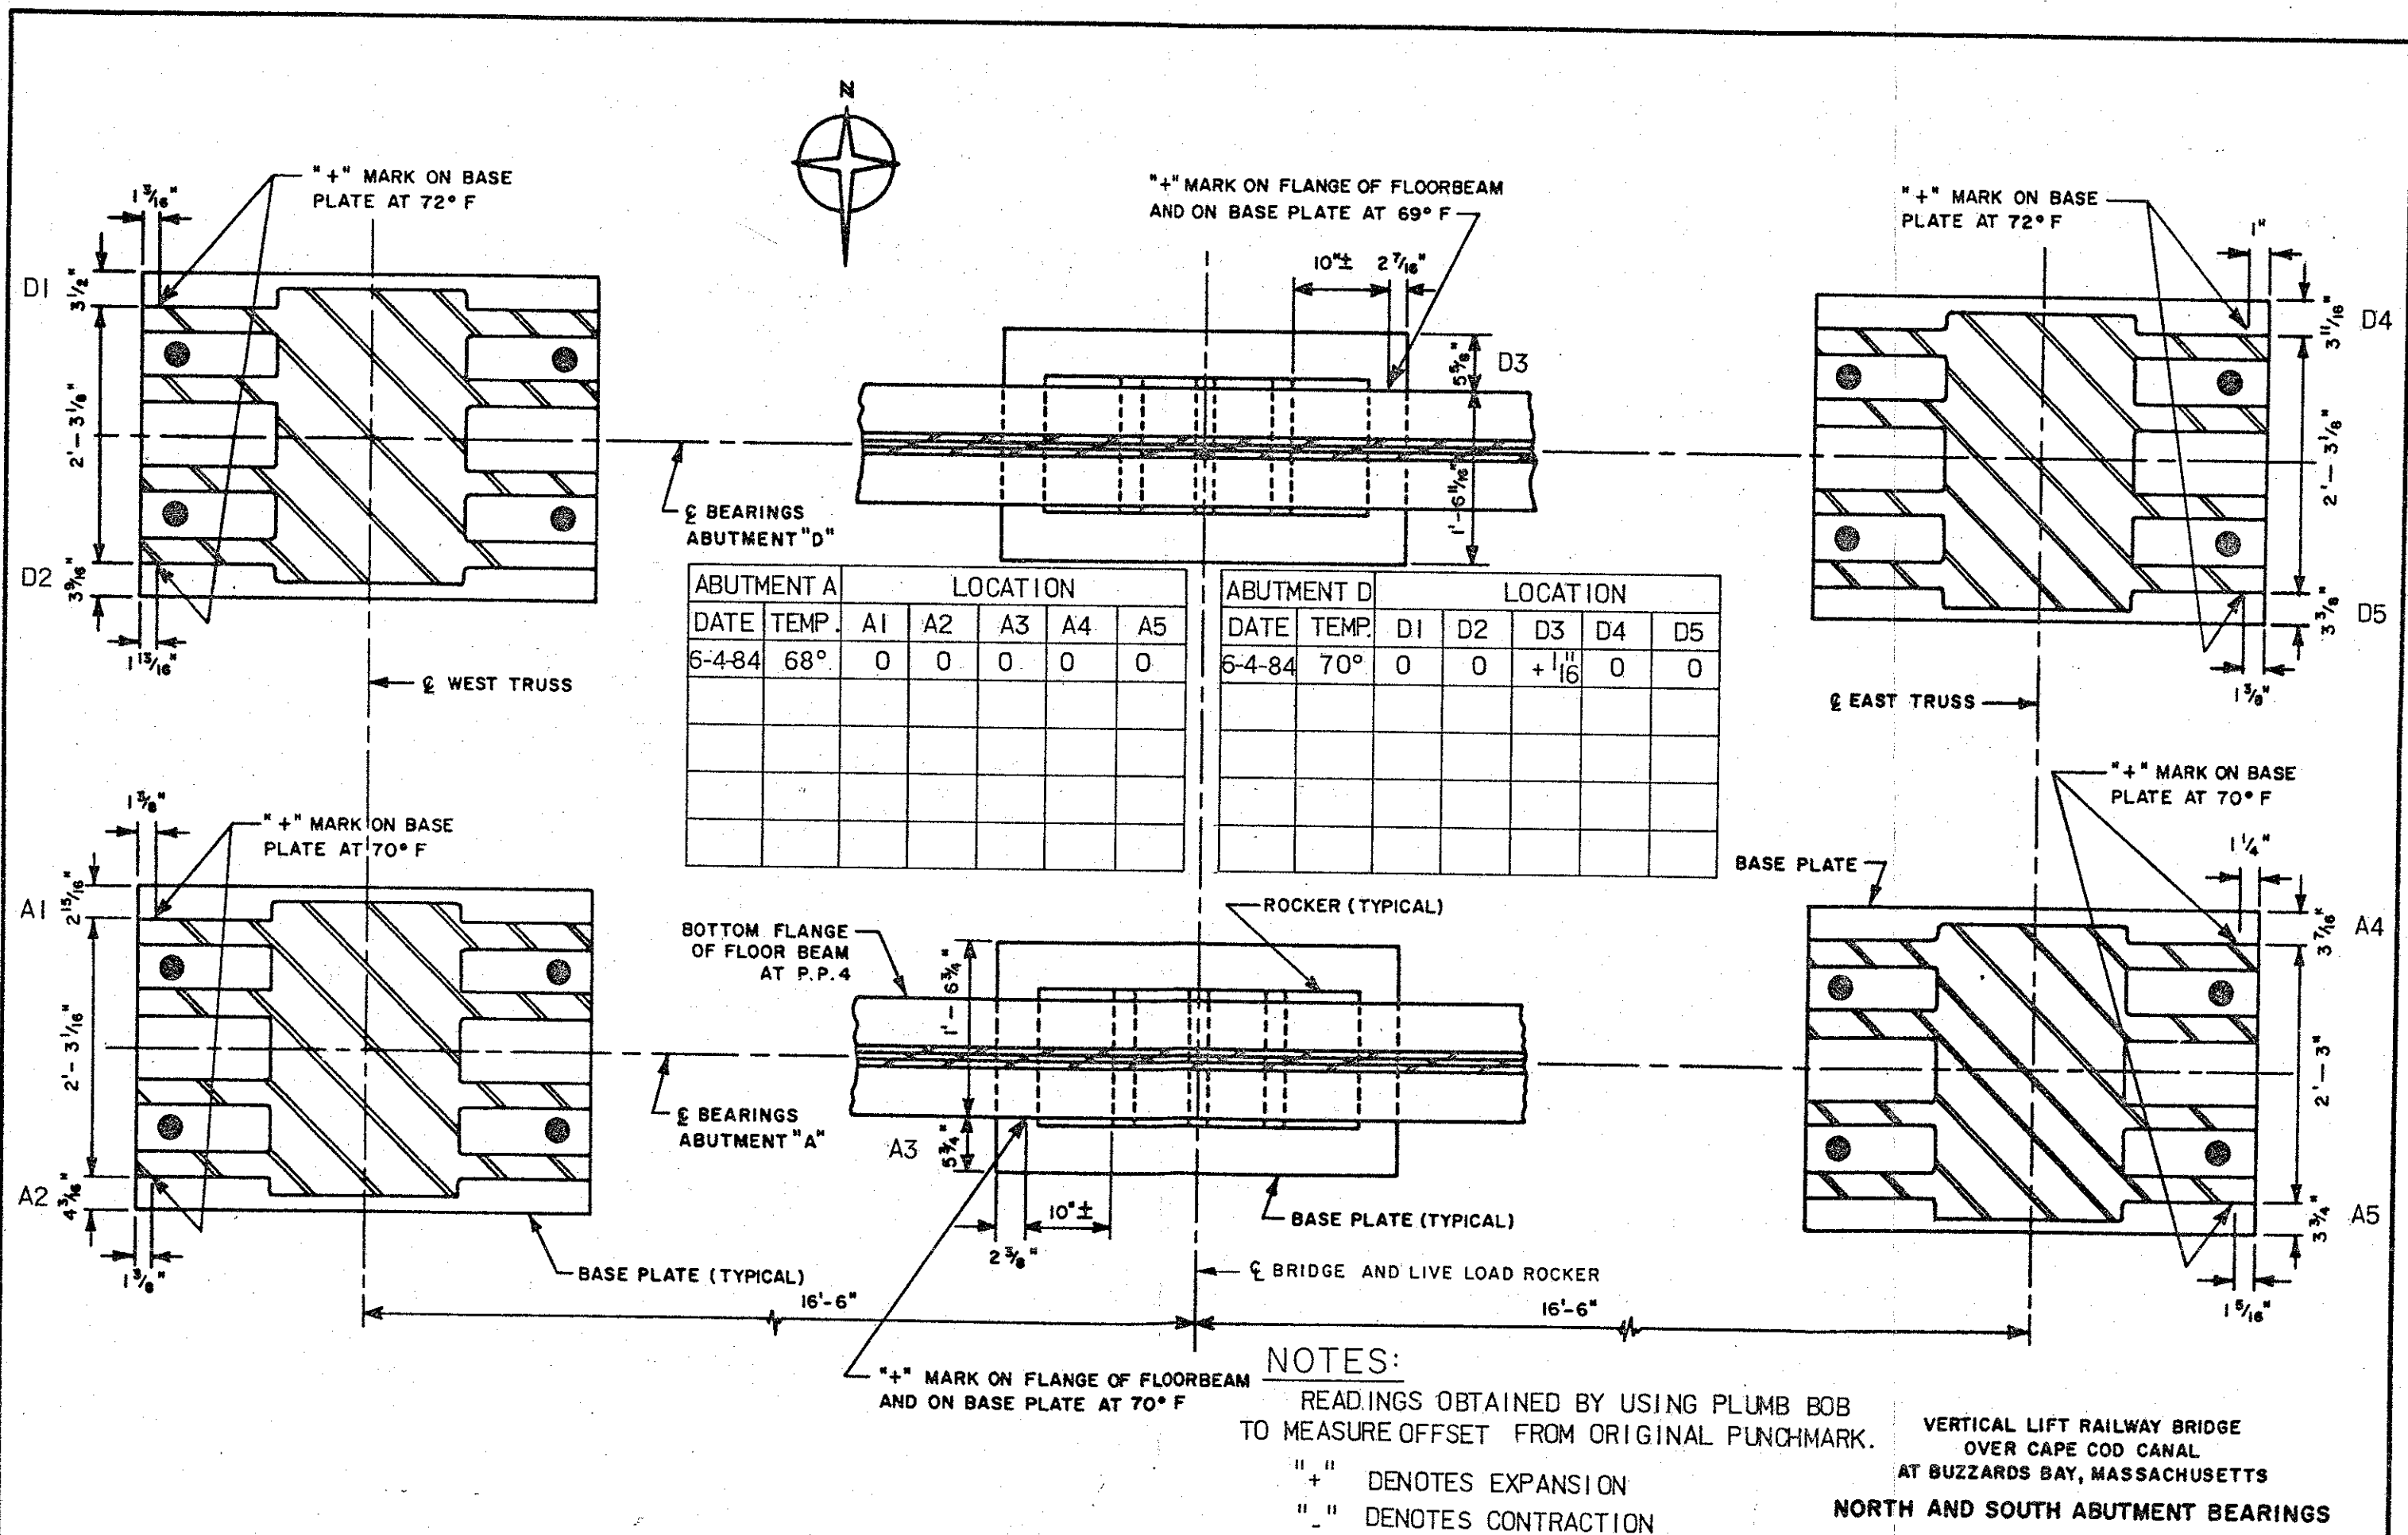
FIGURE 2-5

The position of the abutment expansion bearing upper shoes and rockers was located with respect to marks placed on the fixed base plates of the devices in 1971. The 1984 readings are consistent with the past readings. Figure 2-5 shows the location of the reference marks on the bearing shoes and the changes in the position of the bearings as recorded during this examination.

The position of the upper shoes and rollers on the base plates for the expansion devices has not changed from the position marked during the 1971 structural inspection when adjusted for temperature variation (see Figure 2-5).

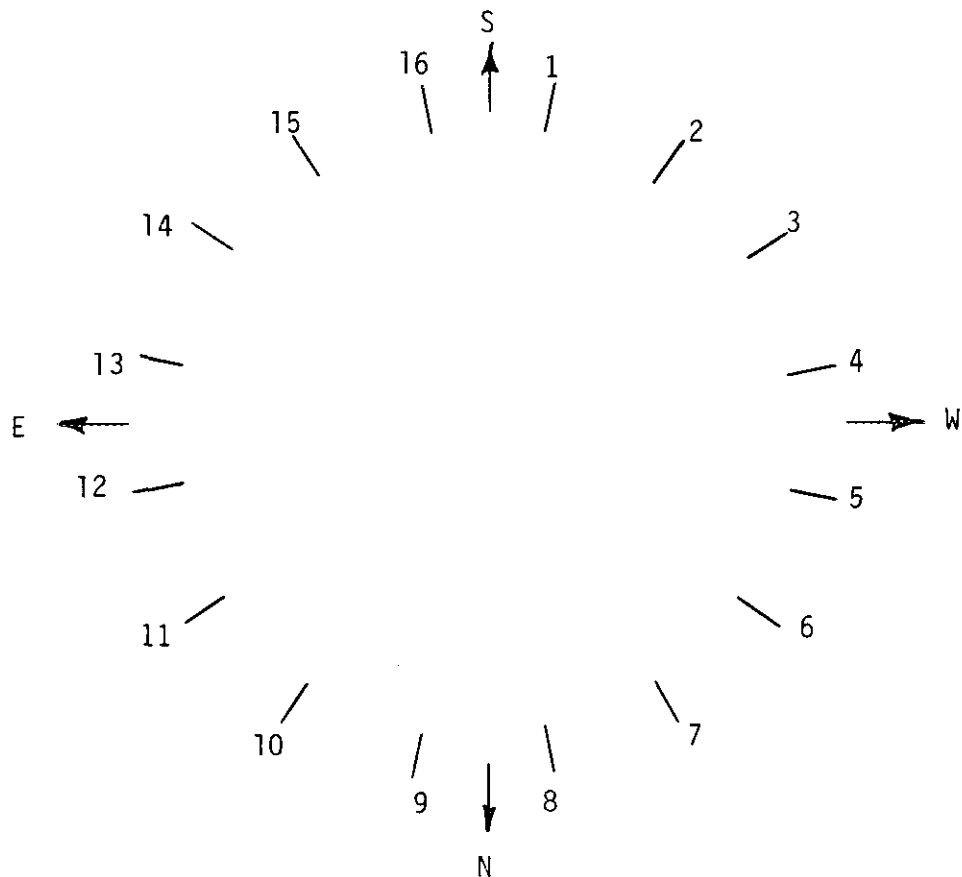
FIGURE 2-7

LOCATION OF BROKEN WELDS AT HORIZONTAL ANGLE CONNECTIONS			
LEVEL NO.	AT VERTICAL NO.	LEVEL NO.	AT VERTICAL NO.
1	15	11	BETWEEN 1 - 2
2	15	11	BETWEEN 2 - 3
3	15	11	BETWEEN 5 - 6
4	1 (3 BROKEN)	11	BETWEEN 10 - 11
4	7, 15, 16	12	2, 5, 7, 16
6	10, 14, 15	12	BETWEEN 3 - 4
7	1, 5, 9, 13, 14	12	BETWEEN 16 - 1
10	5, 9, 13	13	1, 5, 10
11	2, 8	13	BETWEEN 4 - 5 (2 BROKEN)

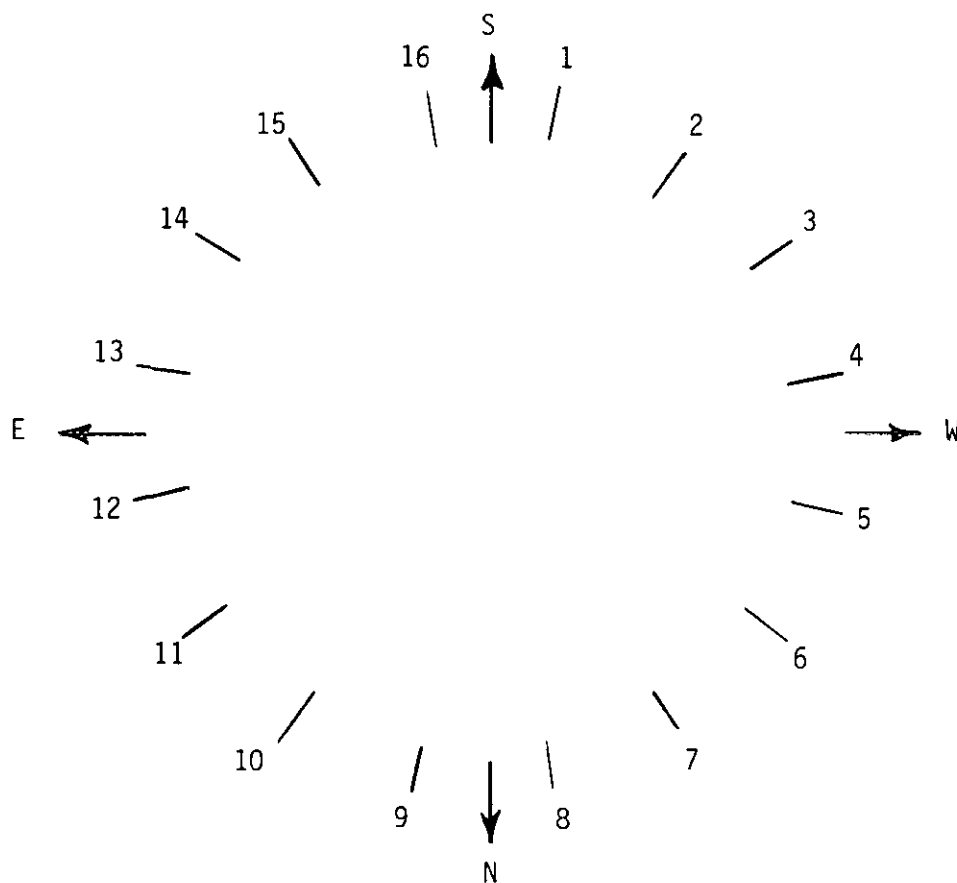
LOCATION OF BROKEN WELDS AT HORIZONTAL ANGLE CONNECTIONS			
LEVEL NO.	AT VERTICAL NO.	LEVEL NO.	AT VERTICAL NO.
3	10	11	ANGLE MISSING BETWEEN 5 - 6
4	1, 7, 12, 15, 16	12	1, 2, 5, 6, 9, 10
6	1 (ON LACING), 3, 4	12	ANGLE MISSING BETWEEN 15 - 16
6	5, 8, 10, 15	12	ANGLE IS CUT BETWEEN 14 - 15
7	1, 4, 5, 6, 7	13	2, 11, 12
8	1, 5, 6, 10	14	3, 15
9	1, 2, 6, 7, 15, 16		
10	1, 3, 11, 12, 13, 16		
11	2, 3, 4, 5, 9, 11, 15

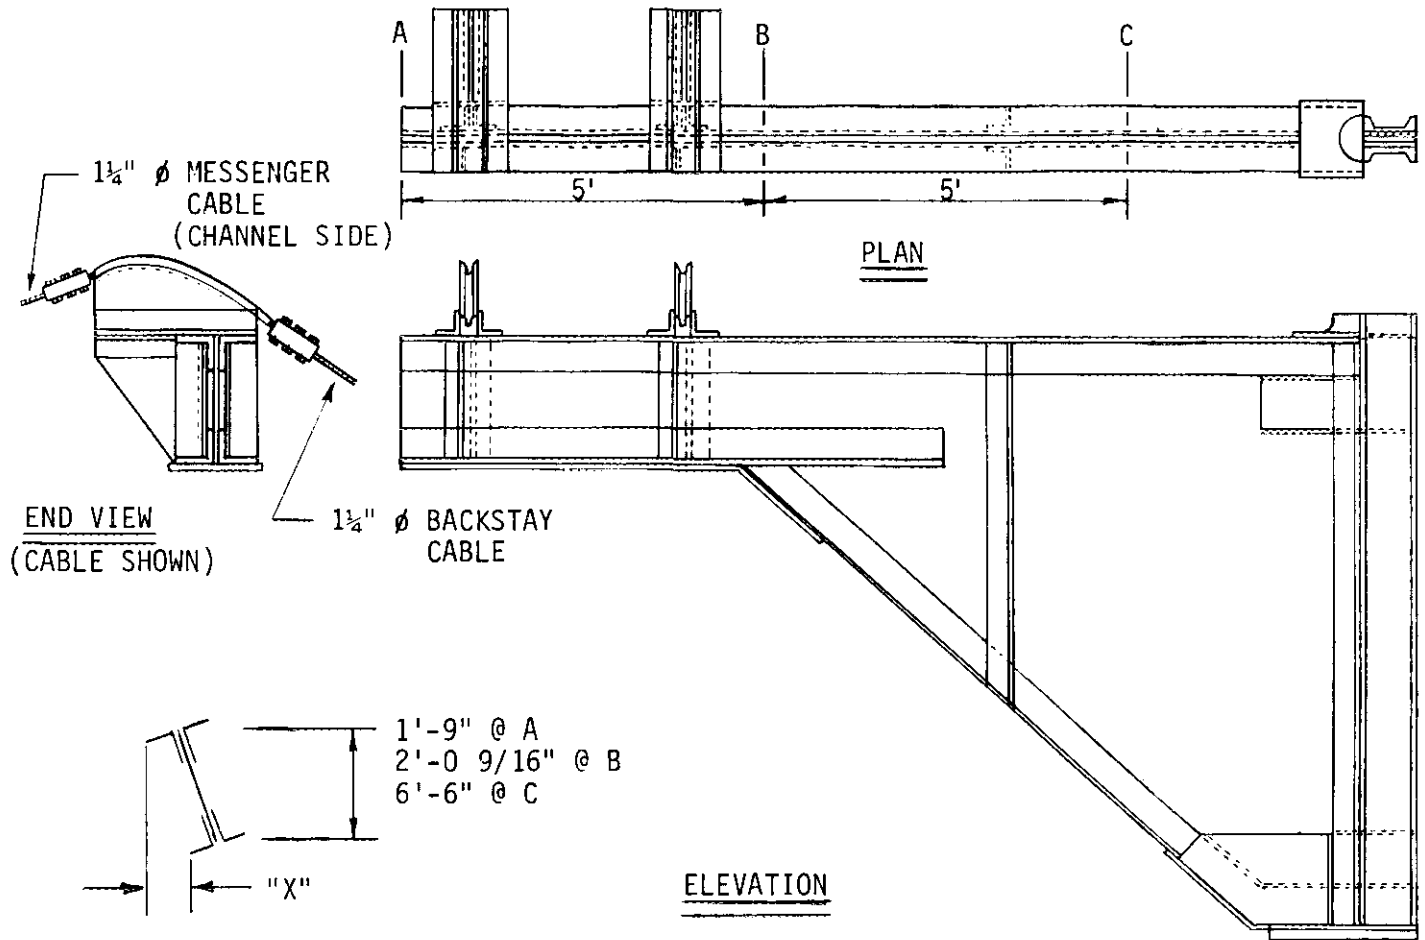
FIGURE 2-8

- f) Similar quantities of bird waste and miscellaneous debris accumulation above the machinery room ceiling (see Photographs II-168 and 169).
- g) Bird waste and deteriorated rivets in the machinery house roof splice plates under the supports of the four decorative balls. The northeast decorative ball remains dented, as reported in 1971.
- h) Moderate section loss in spire lattice angles adjacent to connection plates and broken welds at many connections. Locations of separated welds are listed in Figure 2-7.
- i) The catenary brackets supporting the messenger cables are pivoted northward and the outboard ends are rotated in the same direction (see Figure 2-8).

BRACKET	ROTATION DIRECTION	LOCATION	DIMENSION "X"	DEGREE OF ROTATION
NORTHEAST	SOUTH	A	1-3/4"	4.8 deg.
		B	3/4"	1.7 deg.
		C	1/2"	0.4 deg.
NORTHWEST	SOUTH	A	2-7/8"	7.8 deg.
		B	1-1/8"	2.6 deg.
		C	3/4"	0.5 deg.
SOUTHEAST	NORTH	A	1-7/8"	5.1 deg.
		B	7/8"	2.0 deg.
		C	3/4"	0.5 deg.
SOUTHWEST	NORTH	A	2-7/8"	7.8 deg.
		B	1-1/4"	2.9 deg.
		C	1/8"	0.1 deg.

- NOTES: 1. ROTATION IS TOWARDS THE CHANNEL IN ALL CASES.
2. THE SOUTHEAST AND NORTHWEST BRACKETS ARE OPPOSITE HAND.

19. Replace the gratings and connection fasteners on the sheave girder bottom flanges adjacent to the counterweight ropes.
20. Analyze the loads on the catenary brackets atop the towers to determine if corrective measures are required.
21. Replace four fasteners at the southwest corner and six fasteners at the southeast corner of the sheave girder enclosure.
22. Remove corrosion deposits and refasten the separated bracing members in the spire lattice at locations indicated on Figure 2-7. Bracing members with excessive section loss should be replaced.
23. Replace 18 rivets in the roof splice plate below each support for the four decorative balls.
24. Replace broken machinery house window panes and the metal frame around the single pane in the west entrance door to the sheave room.

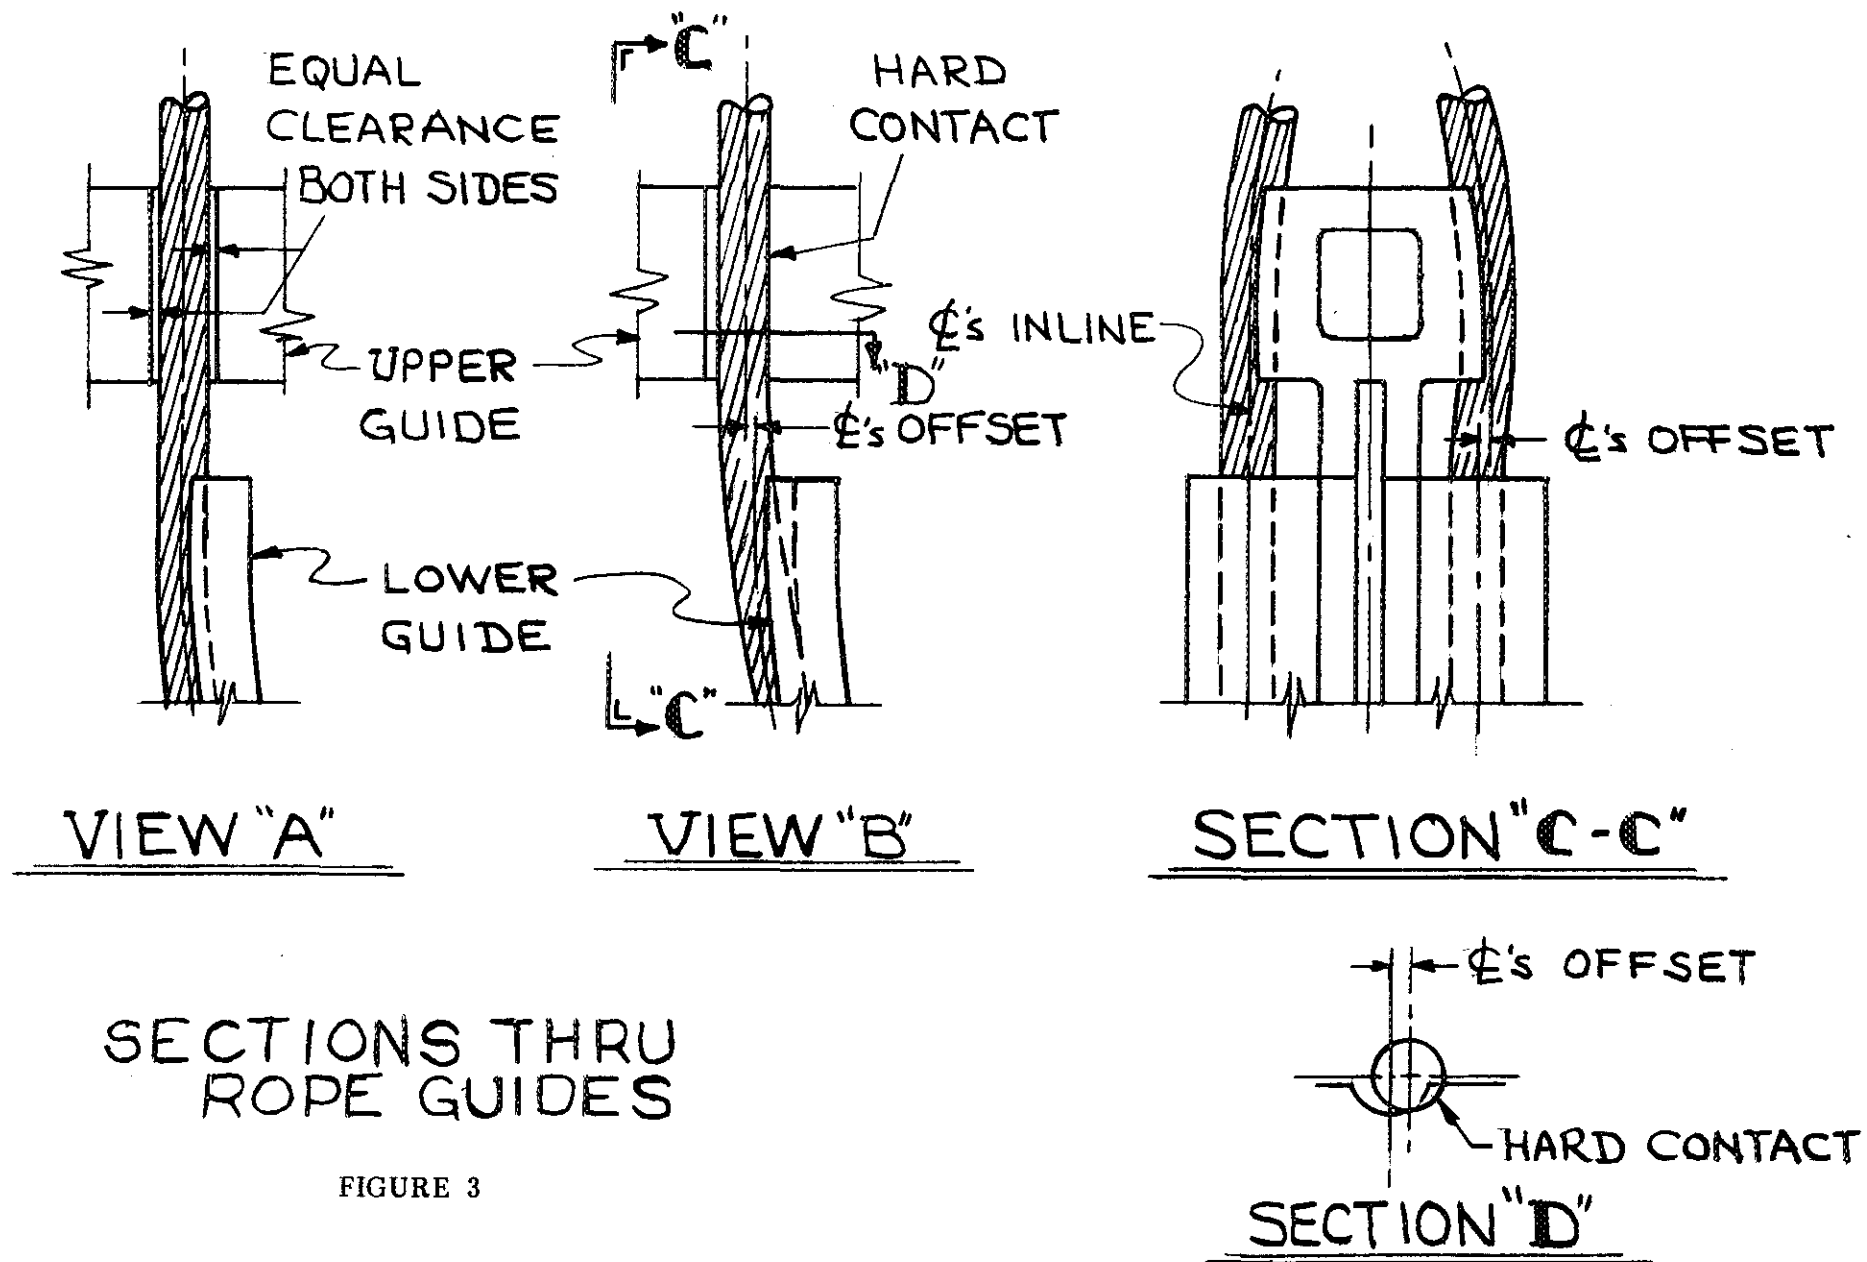
Unfortunately, the grooves in the upper rope guides do not have the same spacing, nor are they properly aligned with the grooves in the lower rope guides, as shown in Figure 3.

Figure 3, View A, shows the centerlines of the grooves properly in line with one another in a north-south plane. View B shows centerlines of the grooves offset from one another. In Section C, the grooves on the left side of the guides are in line in an east-west plane, while those on the right side are offset.

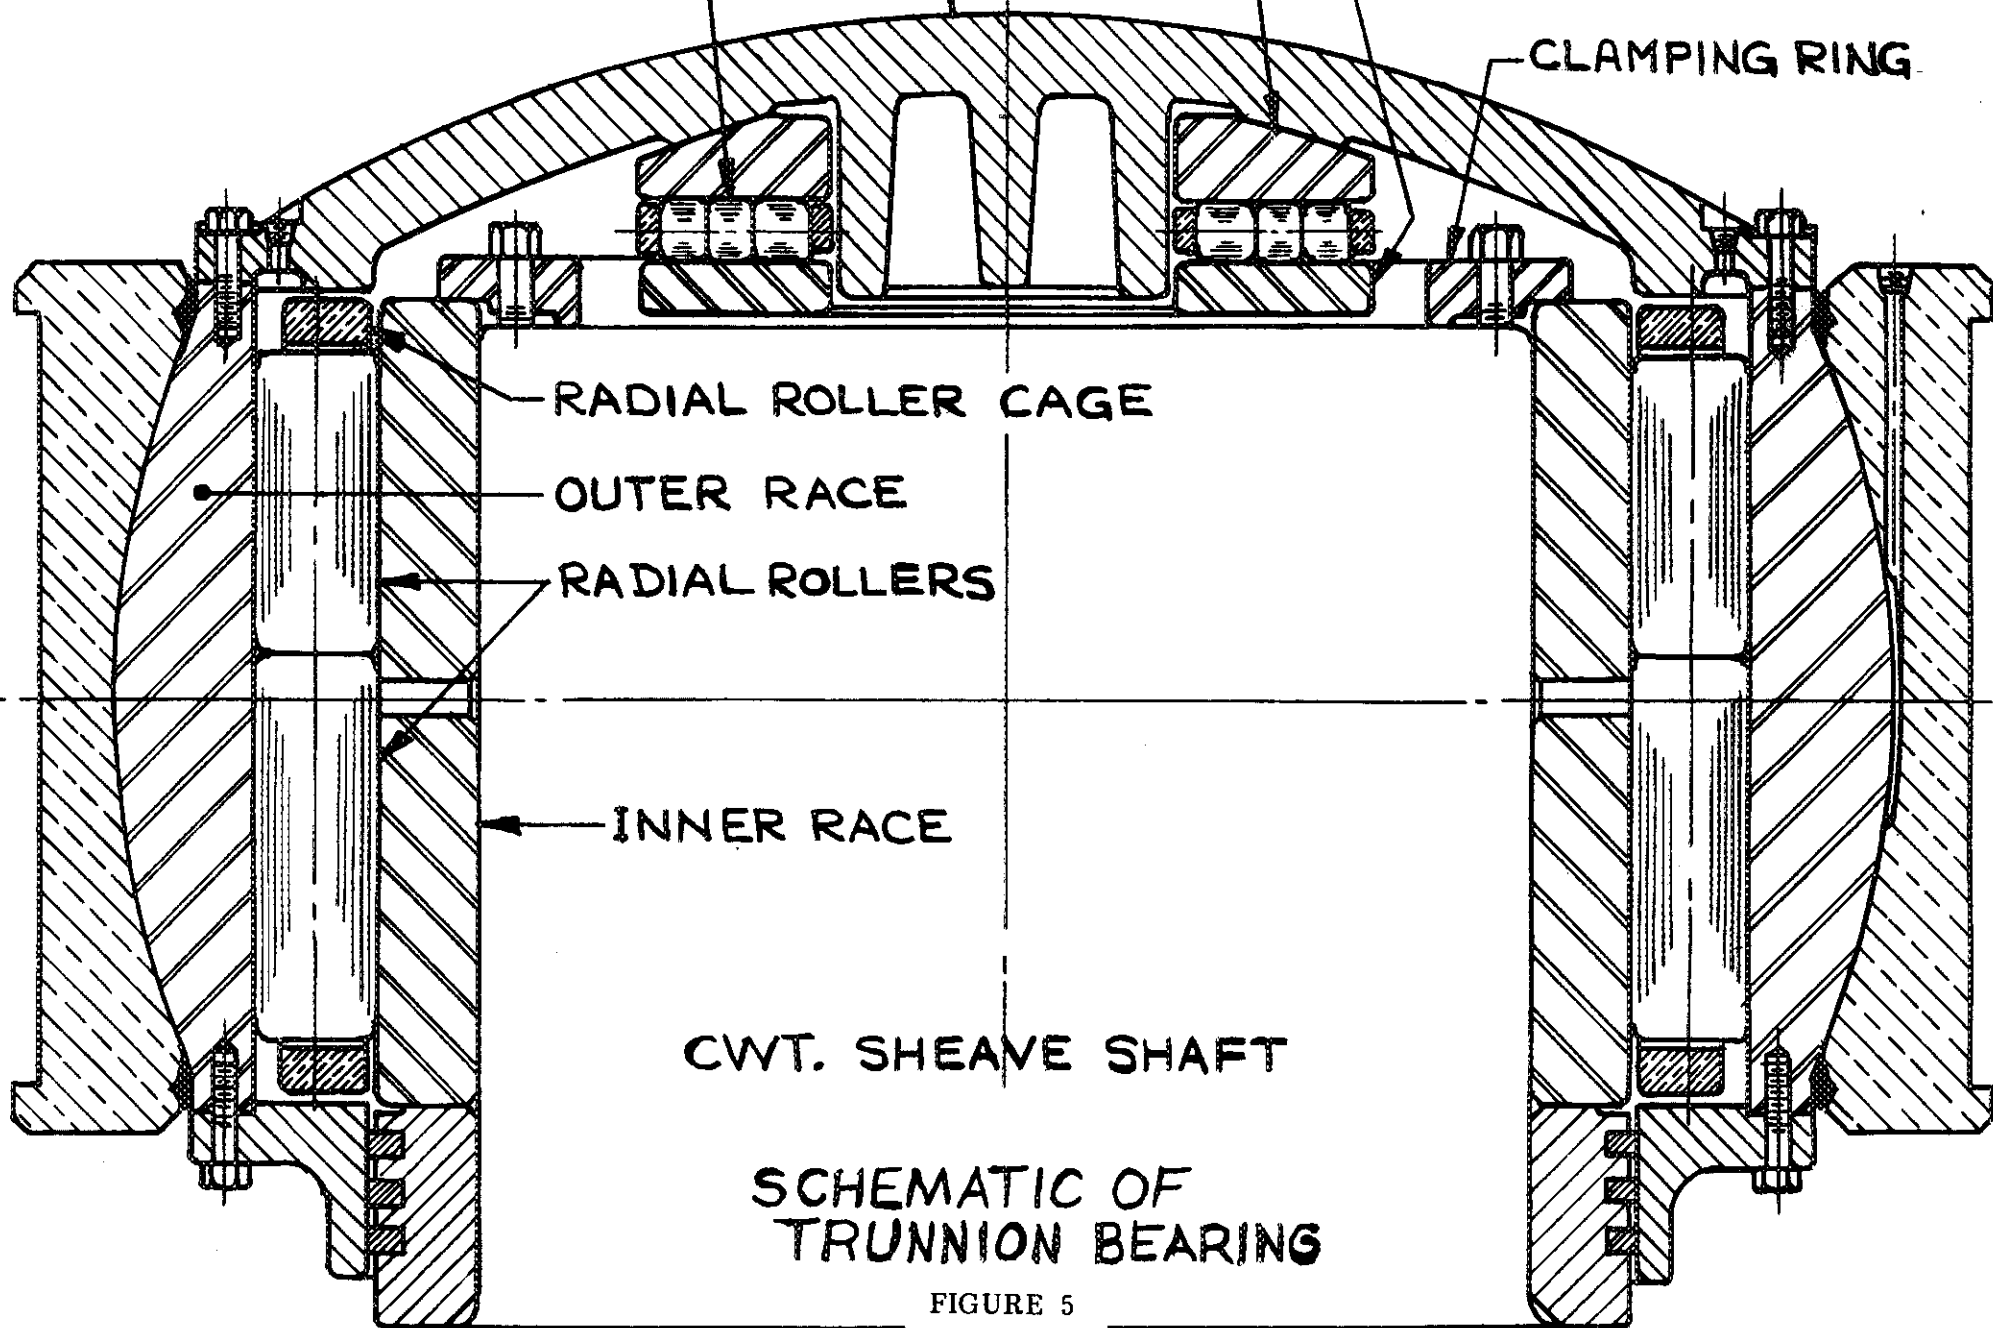
FIGURE 5

Three elements of the thrust washer are supported by the boss, as seen in the schematic in Figure 5. The flat thrust washer rides on the end of the boss. The flat washer had worn a sizeable groove in the top of the boss, as seen in the photograph.

The thrust rollers were found to have substantial heat discoloration, as seen in Photograph 88. The spherical washer and the flat washer were also found to have heat discoloration. The side of the flat washer that the rollers contact can be seen in Photograph 89.

11. Replace counterweight trunnion bearings assemblies. Use bearings that are dimensionally interchangeable with existing bearings so that existing bearing housings can be reused. Replacement bearings should be spherical roller or tapered roller types that provide both radial and thrust capacity. One bearing on each trunnion shaft should be fixed and the second bearing should float to allow for differential thermal expansion.
12. Replace the entire plumbing system in the control house, per the recommendations included in George Jackson's report in Appendix B.
13. Redesign counterweight guide slippers to provide bronze slipper inserts in each slipper.

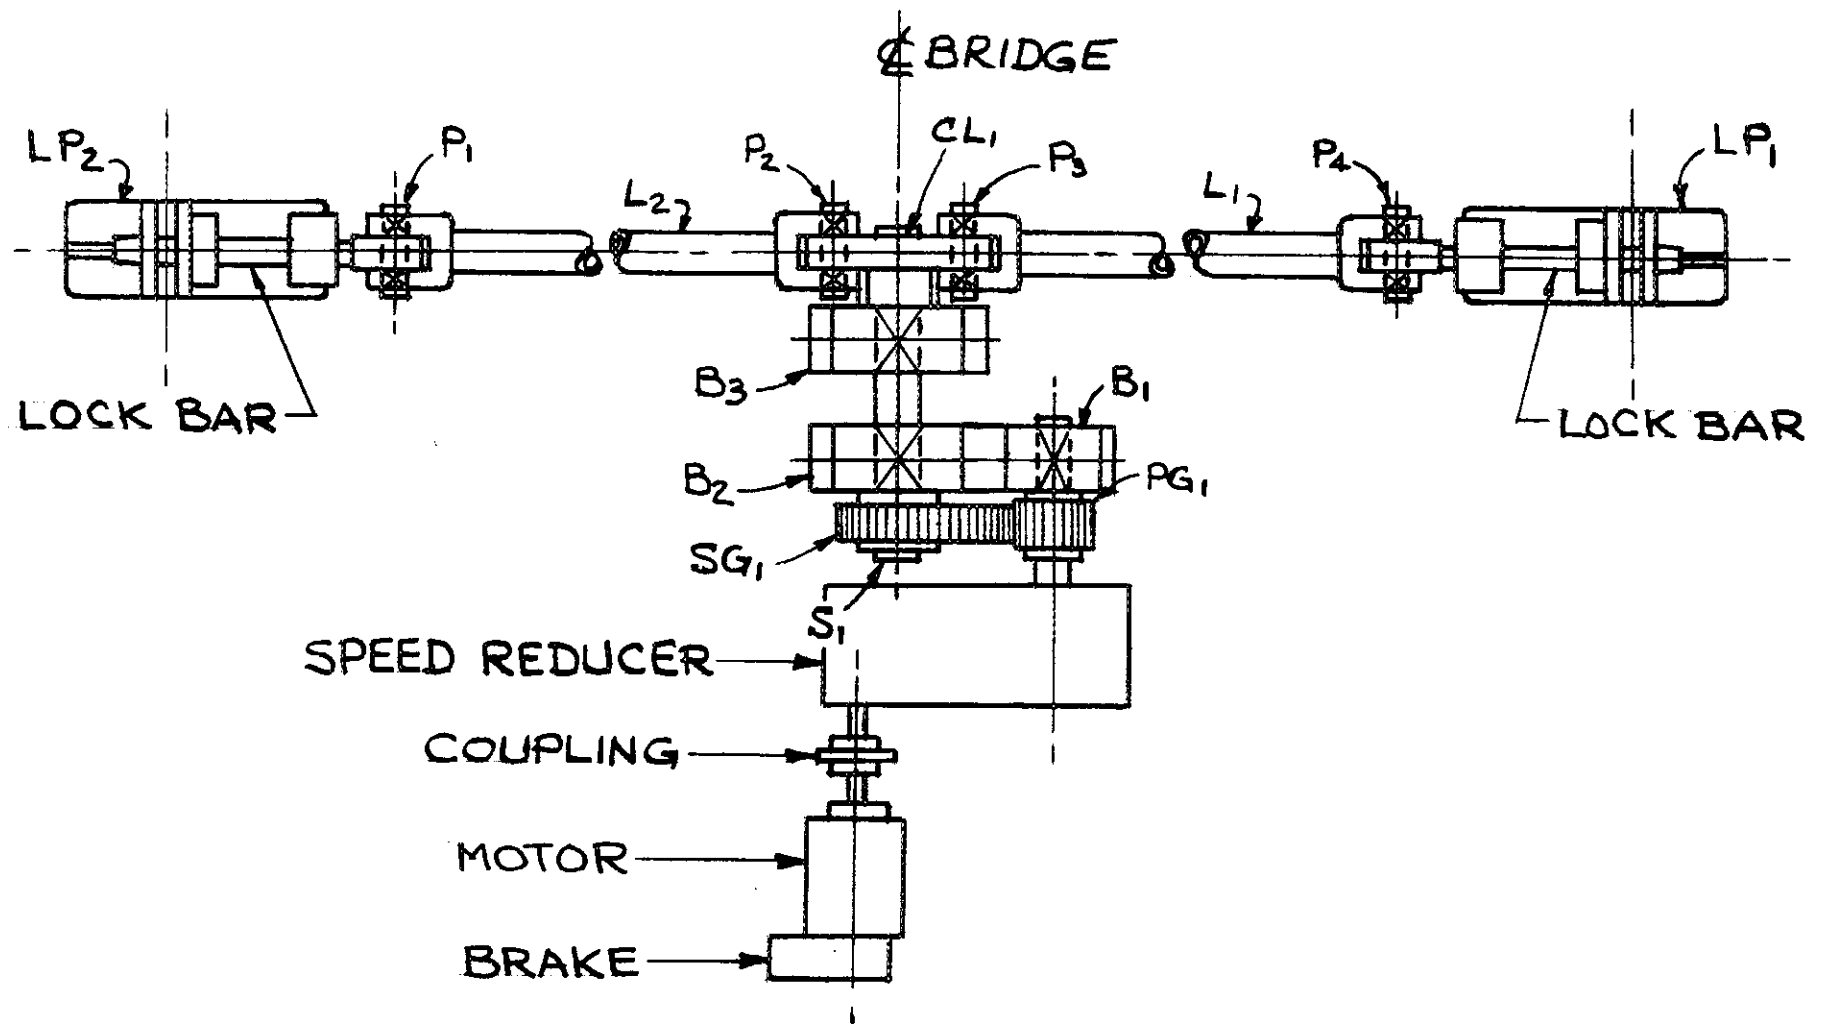
LOWER SPAN LOCK

PART		REMARKS
NAME	#	
BRAKE MOTOR COUPLING SPEED REDUCER		Mounting bracket severely corroded.
		Opened - All internal parts heavily corroded. No lubricant present. Grid fractured.
		Opened - Oil in housing heavily contaminated. Much foreign matter and sludge in bottom of housing and in oil passages. Seal leaks on input shaft.
PINION GEAR	PG ₁	Teeth on both gears have experienced severe loss of metal due to corrosion.
GEAR	SG ₁	Was not being lubricated until recently.
BEARING	B ₁	Clearance .008".
BEARING	B ₂	Clearance .012". Nuts on cap bolts heavily corroded.
BEARING	B ₃	Clearance .012".
CONNECT ROD	L ₁	Bolts and nuts used to attach clevis at each end heavily corroded.
CONNECT ROD	L ₂	Bolts and nuts used to attach clevis at each end heavily corroded.
PIN	P ₁	Clearance .009".
PIN	P ₂	Clearance .007".
PIN	P ₃	Clearance .010".
PIN	P ₄	Clearance .010".
